# WROUGHT IRON *for* UNDERGROUND SERVICES

A TECHNICAL BULLETIN PREPARED BY THE ENGINEERING SERVICE DEPARTMENT

**A. M. BYERS COMPANY • PITTSBURGH, PA.**

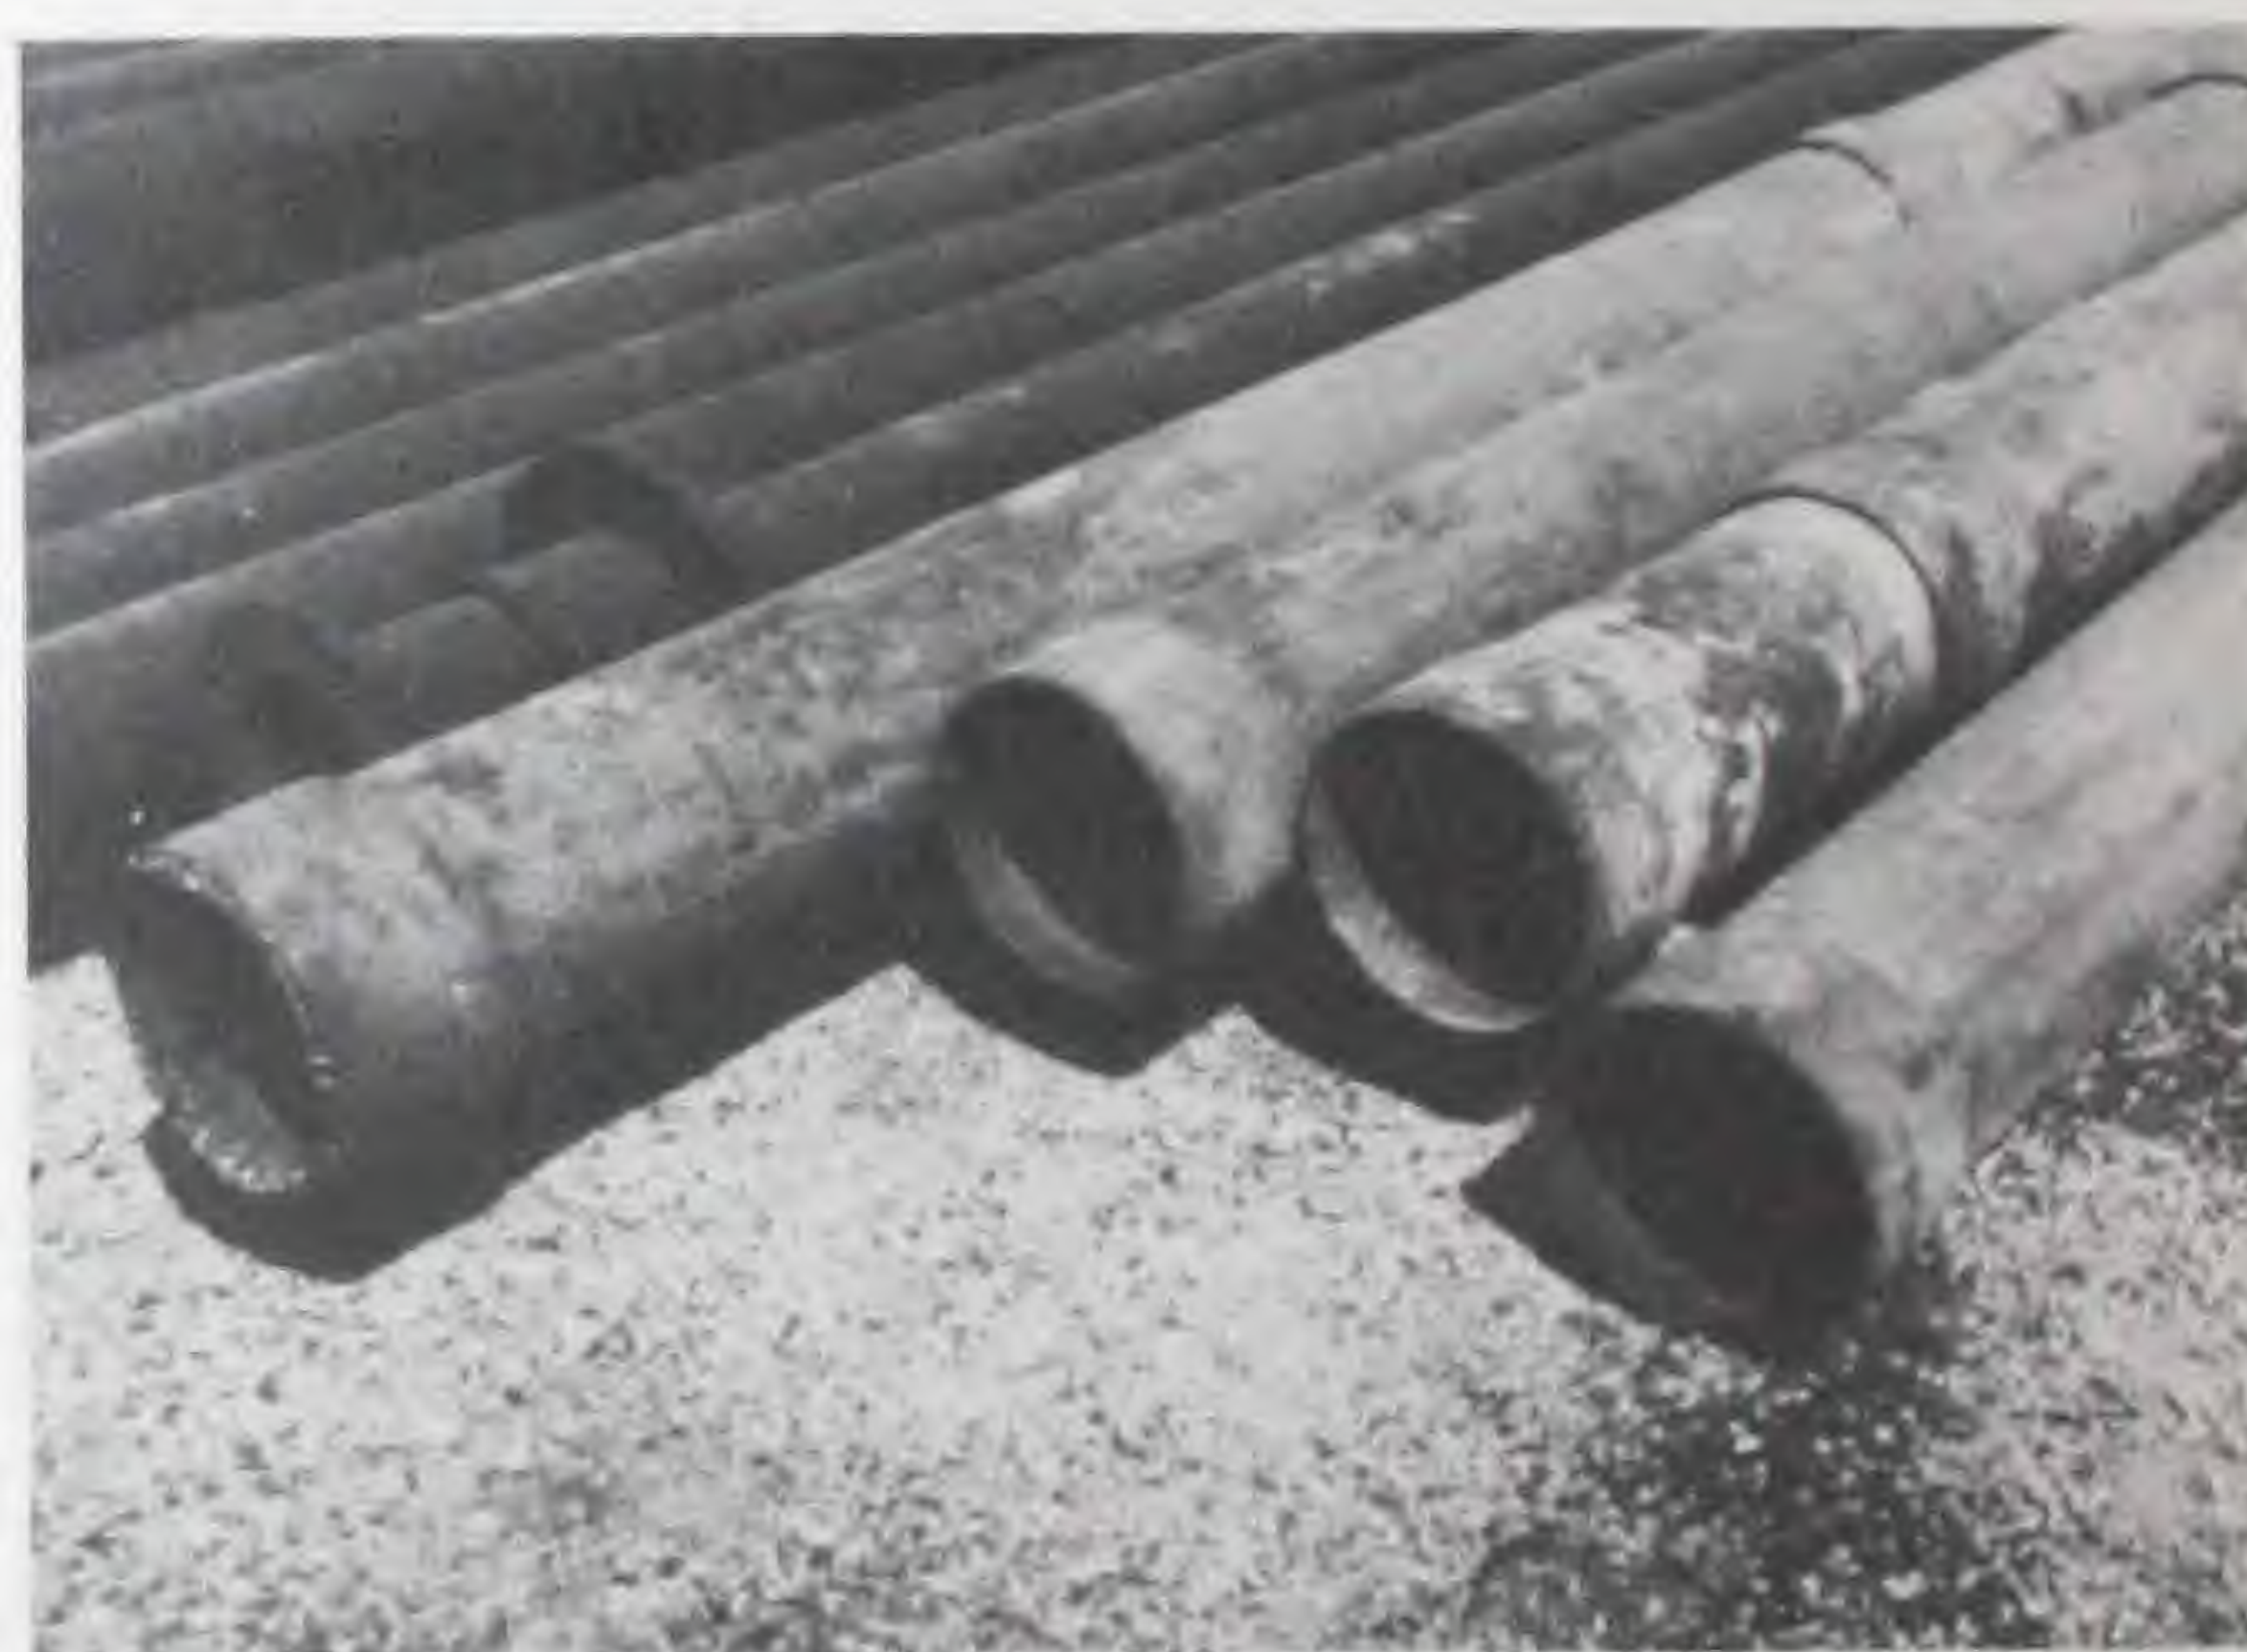
At Rockford, Illinois a 10" well, cased with wrought iron, was deepened and enlarged to 18" diameter in order to obtain increased capacity. The old casing had been in service 52 years and when removed was still in good condition. Fig. 18 shows some of it just as it came out of the well. It was in such good condition that it was reinstalled in another well. Wrought Iron was, of course, used for the new well casing.

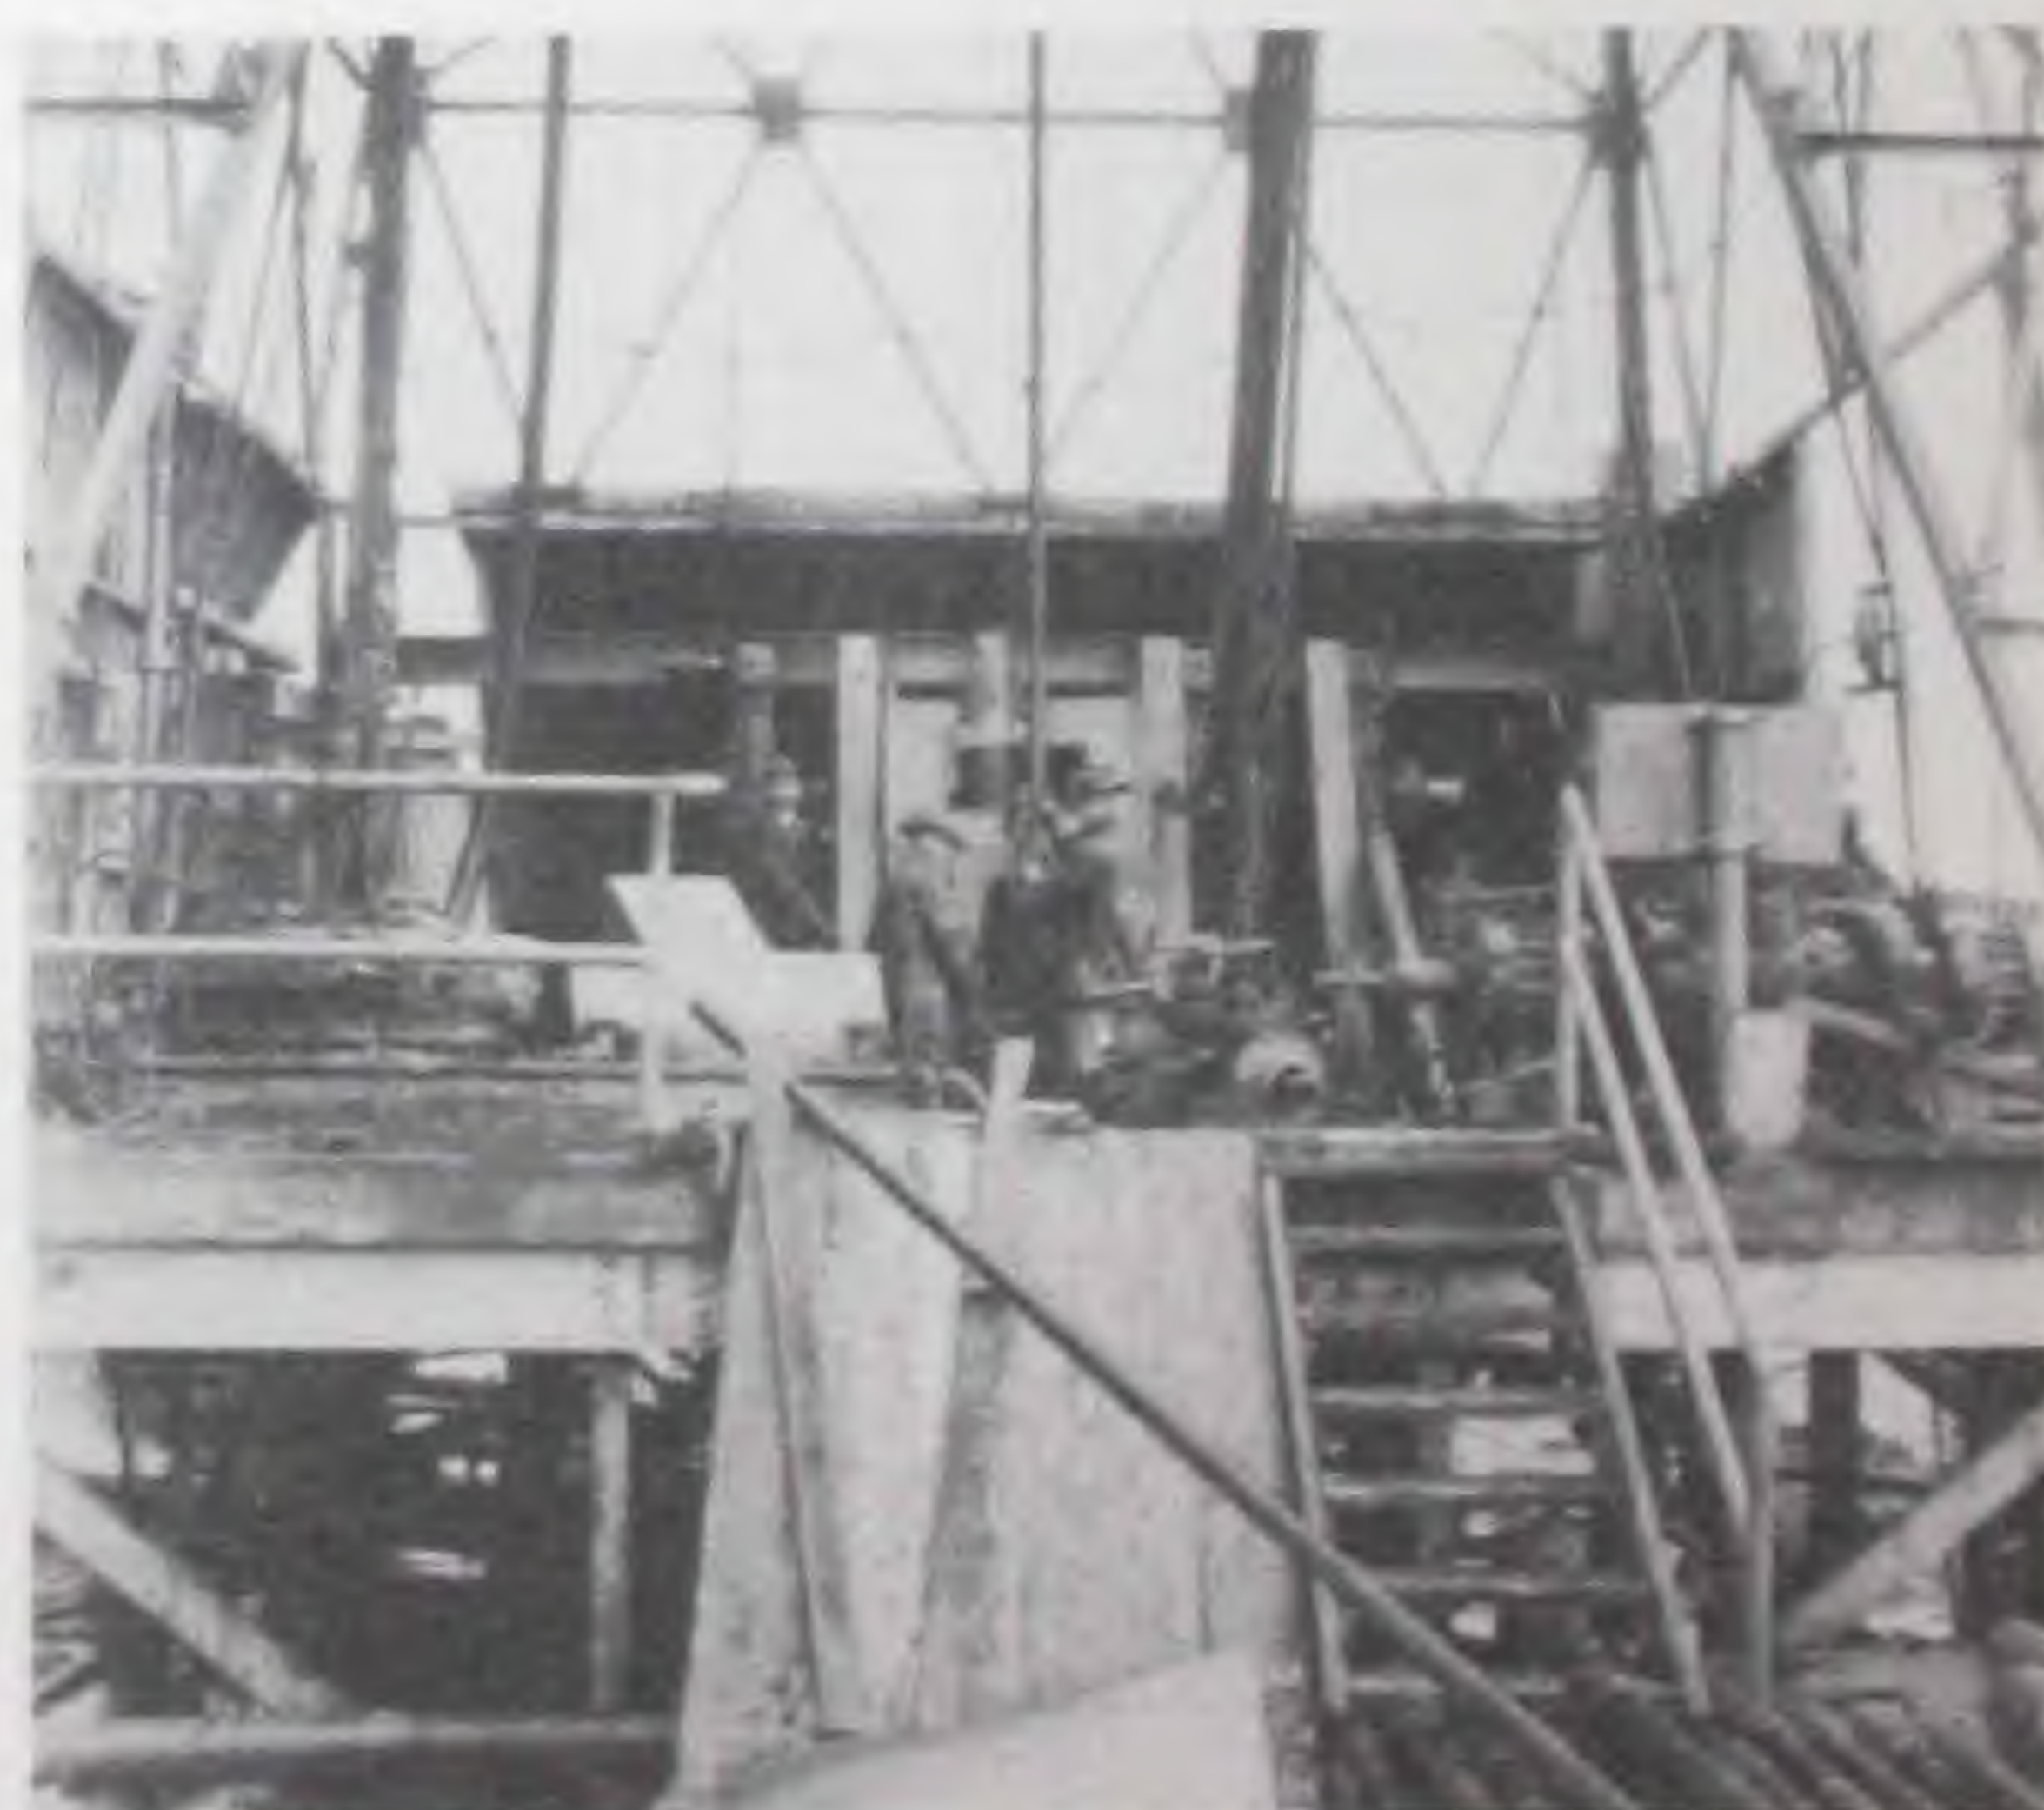
of wrought iron for steel in the wells where the tests were made. Fig. 22 shows wrought iron tubing being installed in one of this company's wells.

In an effort to determine the comparative life of wrought iron and steel tubing, a very extensive series of records was kept by one of the producers in the Gulf Coast area. One hundred forty-four strings of wrought iron tubing were studied, and the average ratio of wrought iron life to steel life was 2.12 to 1. A report was carefully compiled by the company's own engineers, and a net saving of over \$200,000 was indicated as having actually resulted from the substitution

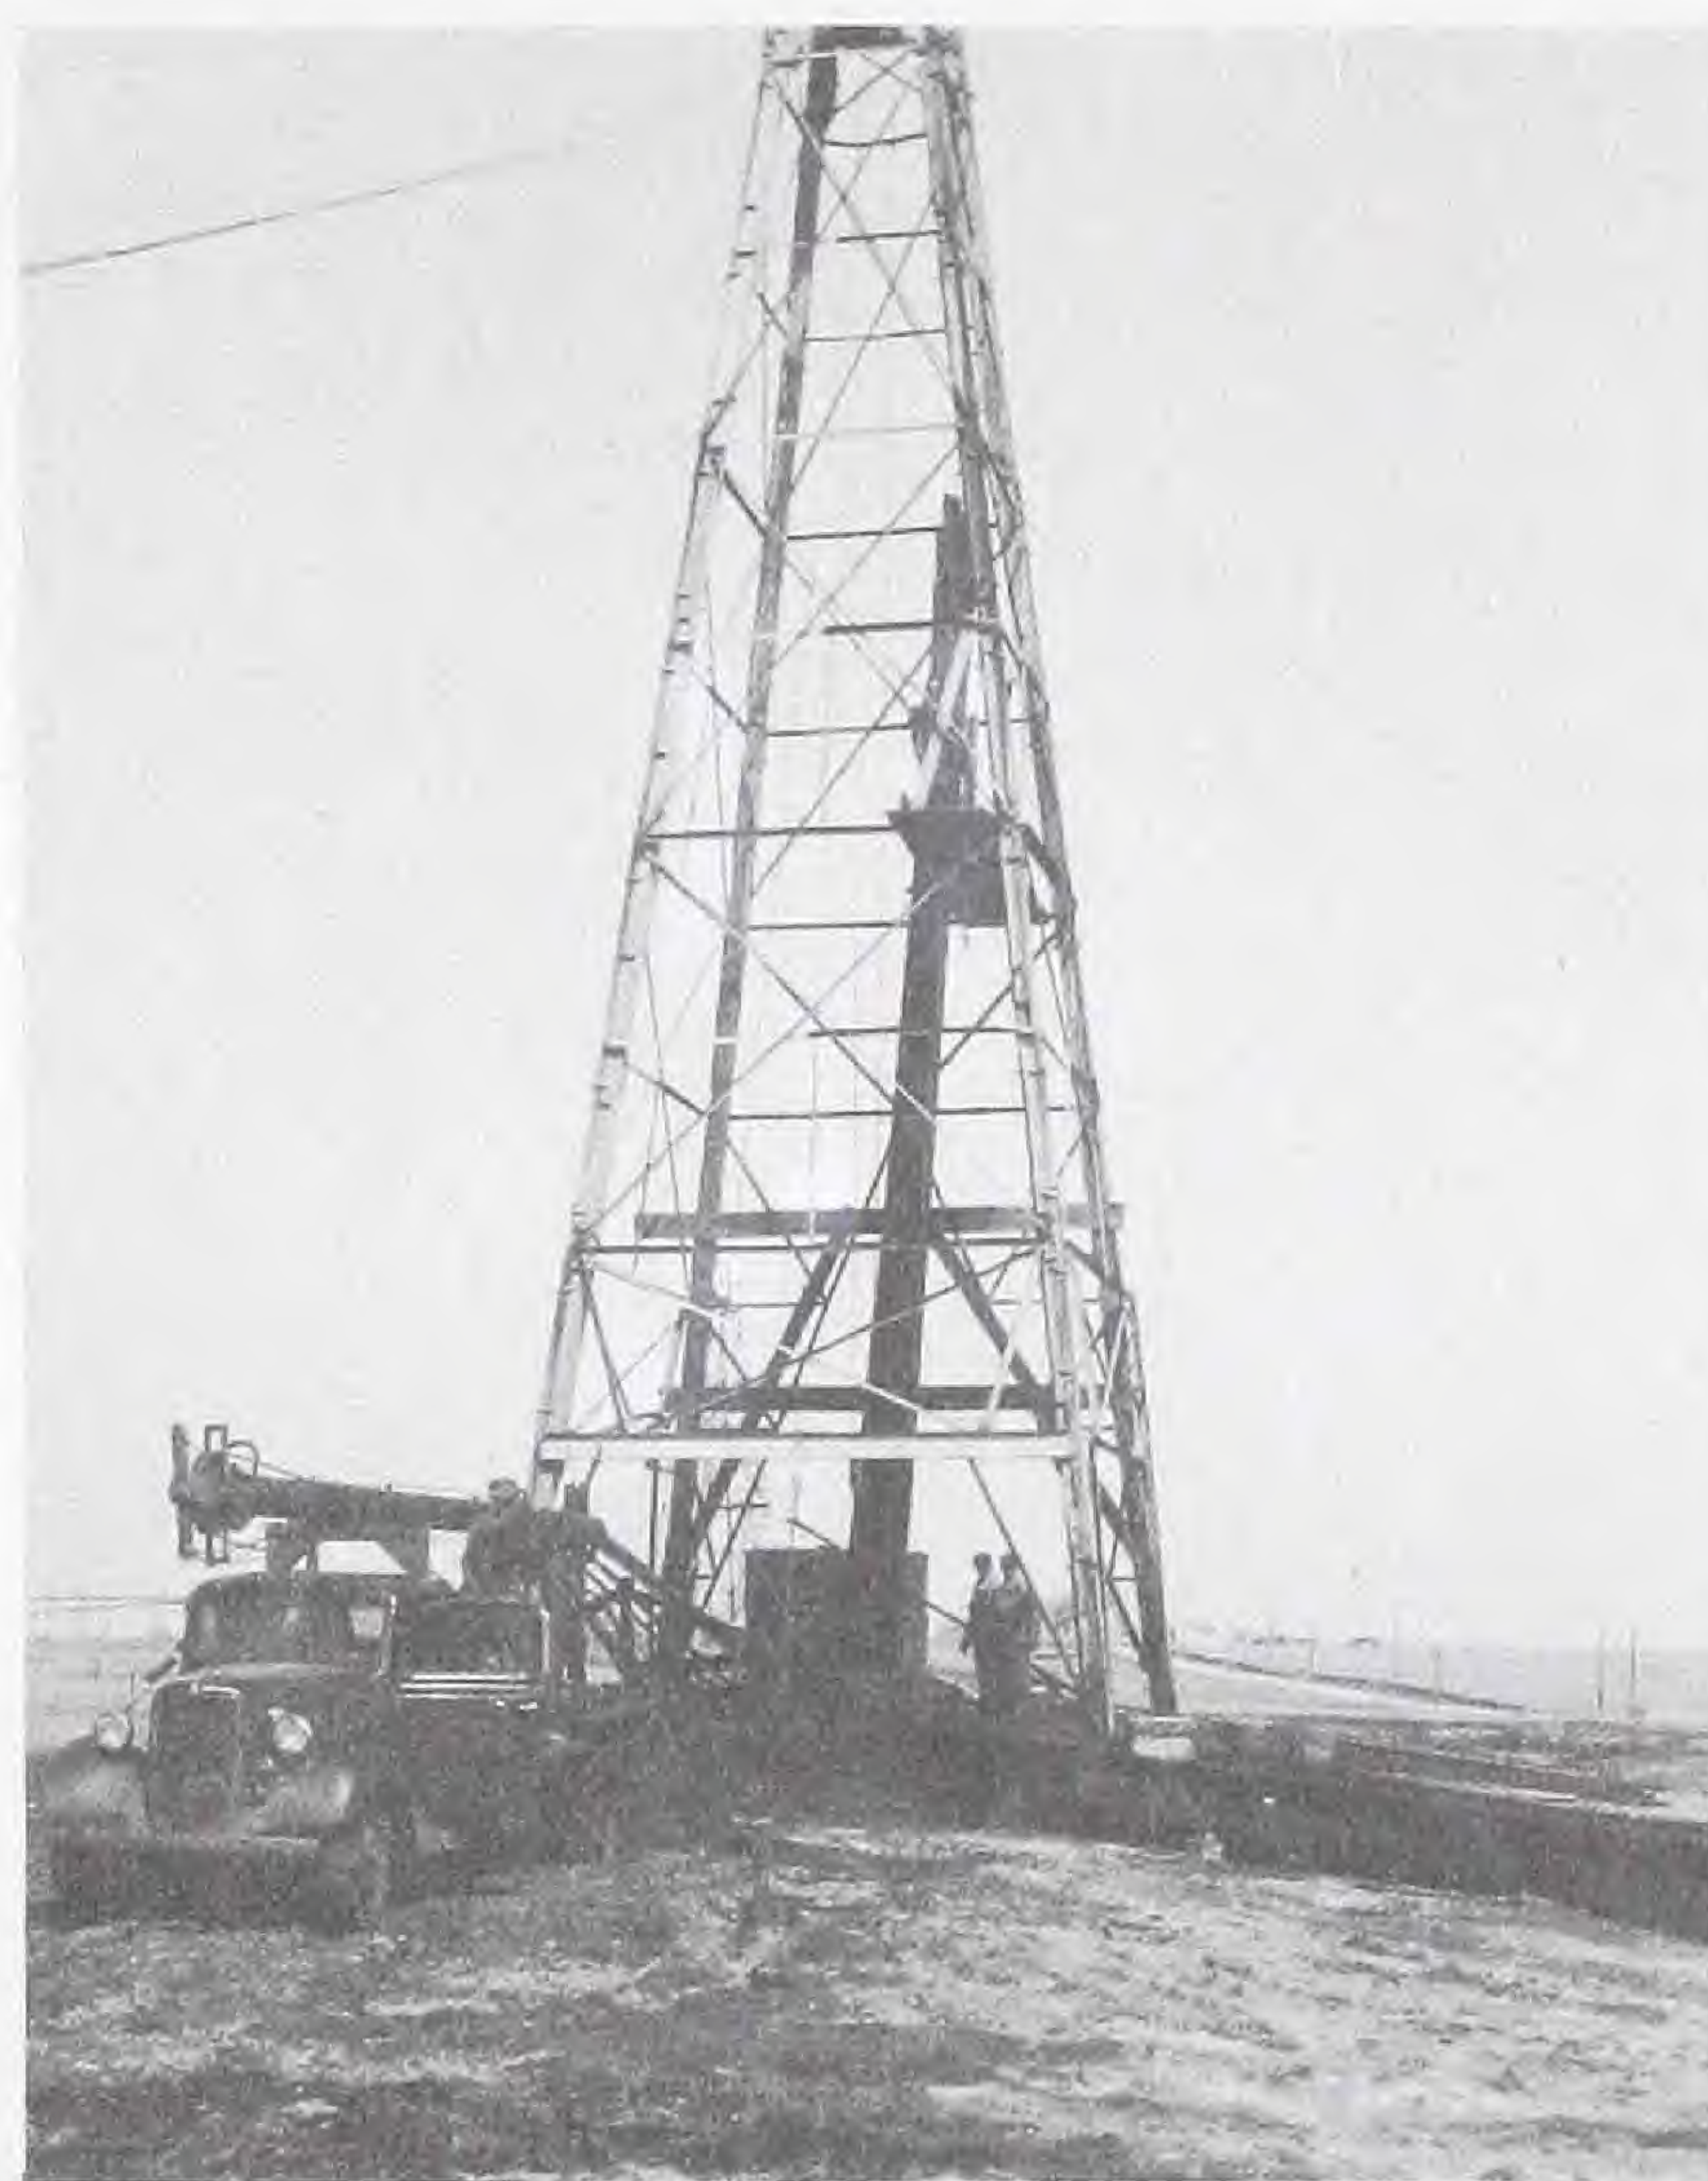
Fig. 24

Figure 24 shows black wrought iron tubing ready to be run into another of the same company's wells.

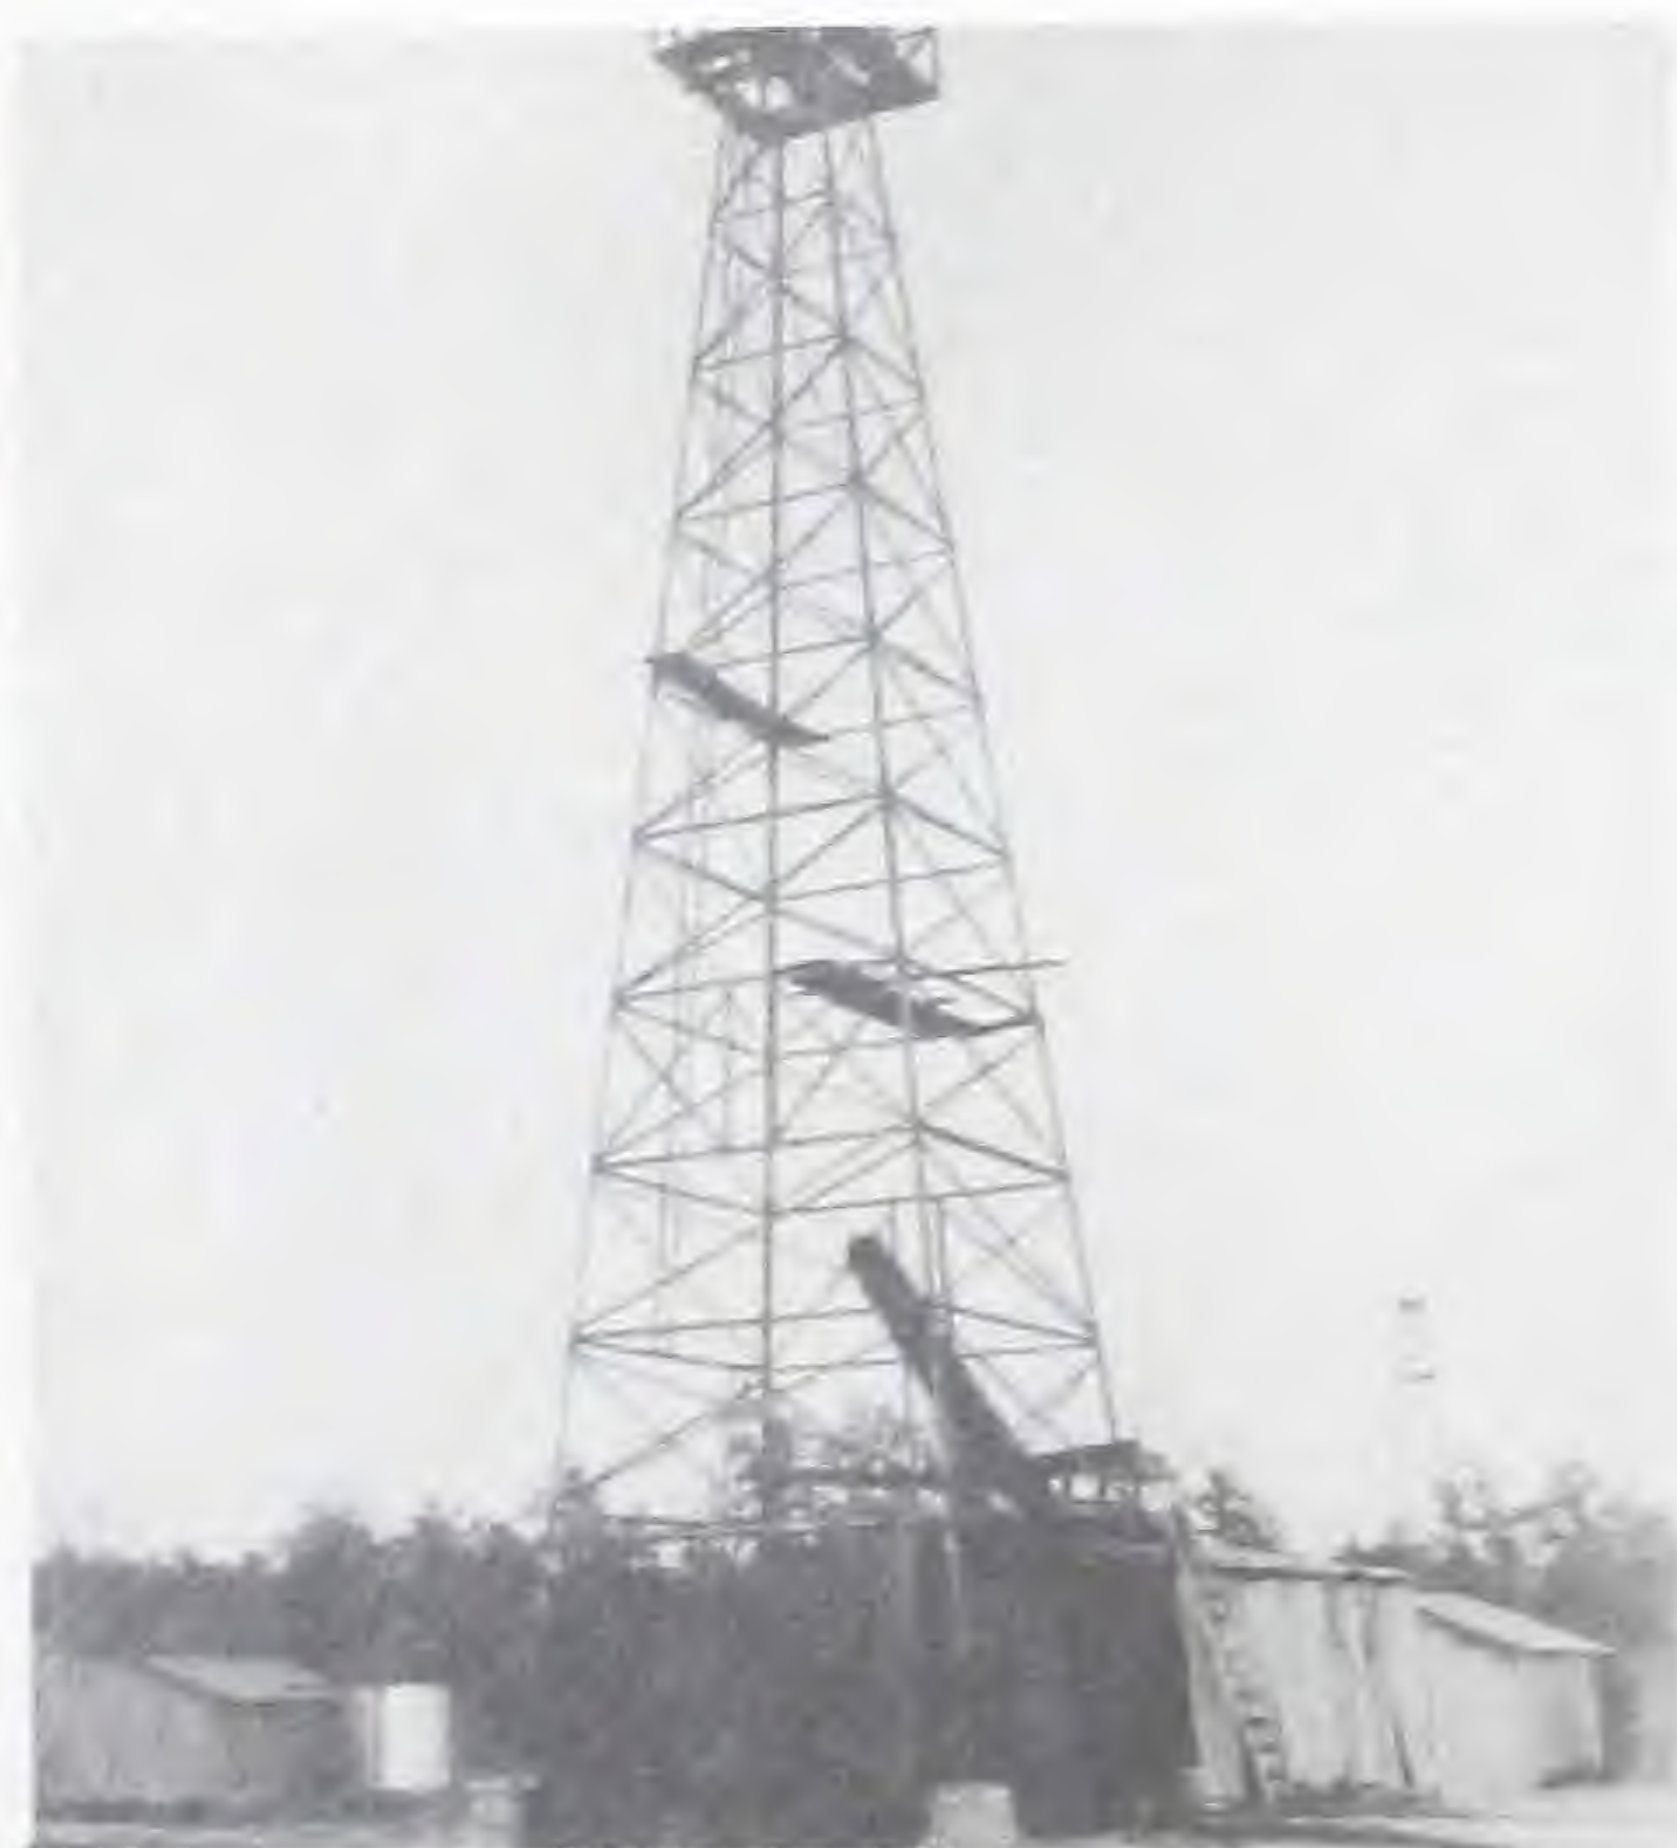
Fig. 25

The well in which the tubing strings were run is shown in Figure 25.

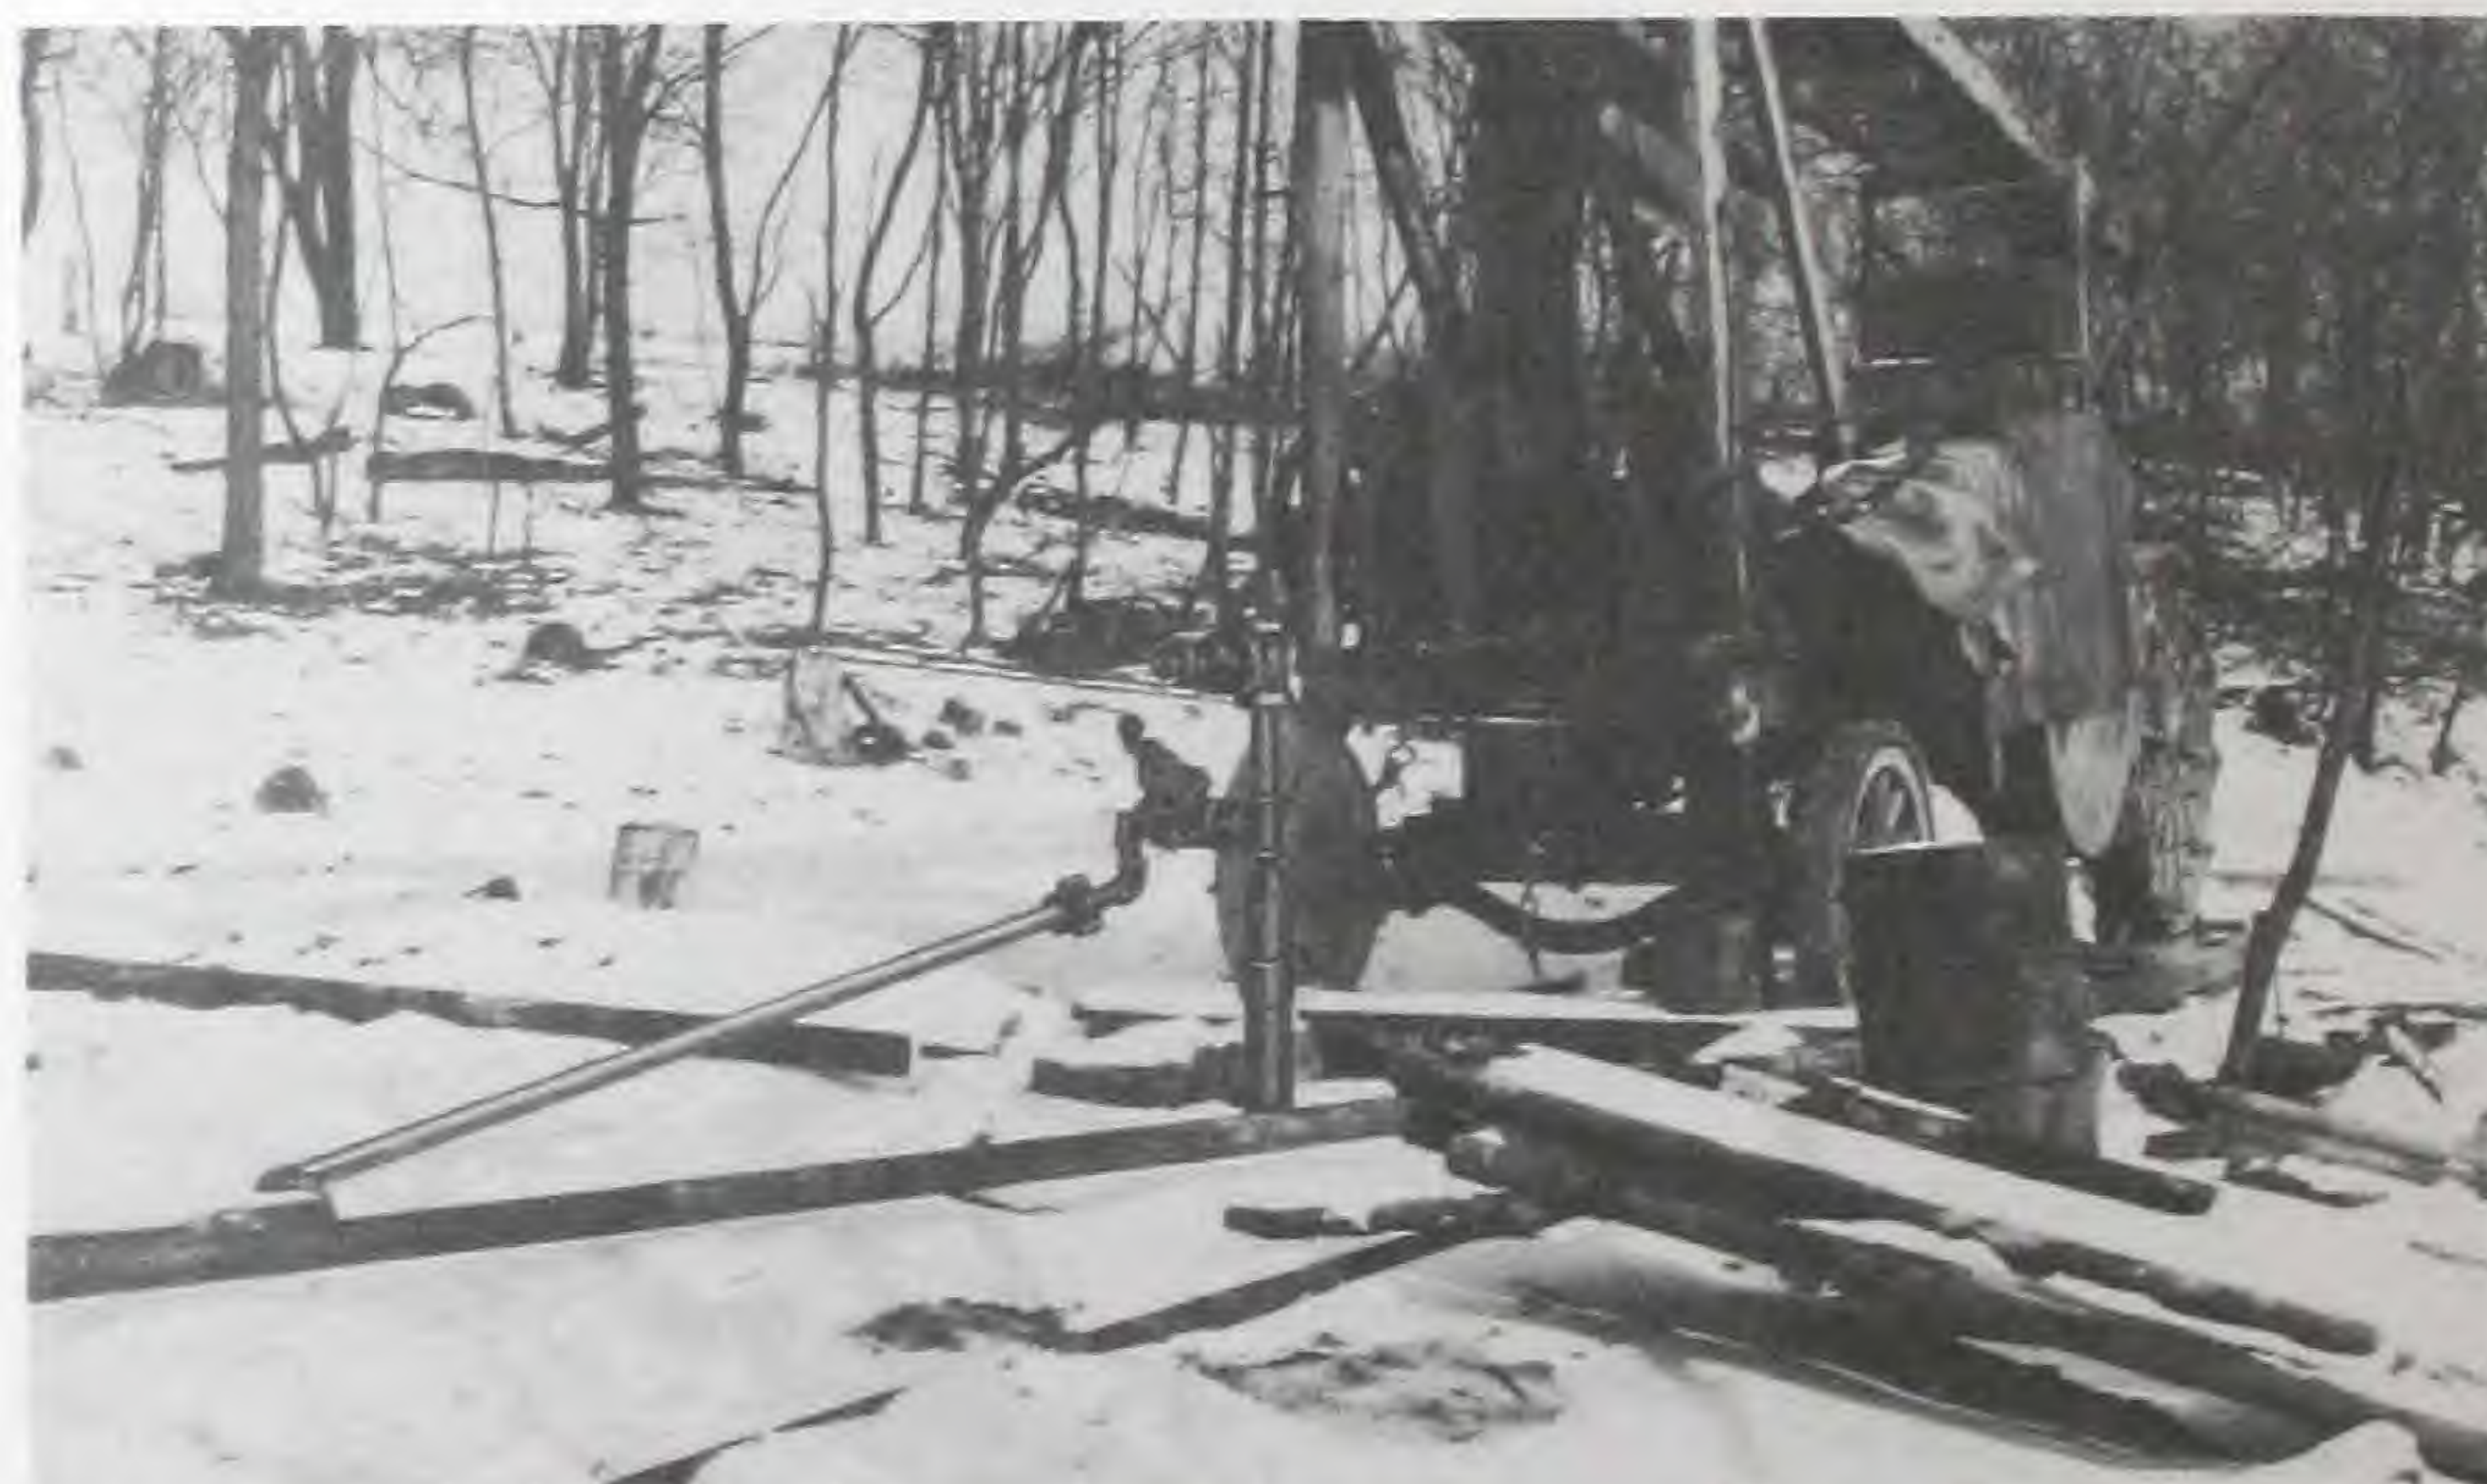
Fig. 26

The well shown in Fig. 26, was drilled near Chicora, Pennsylvania, at the time of the first "oil excitement" in that territory.

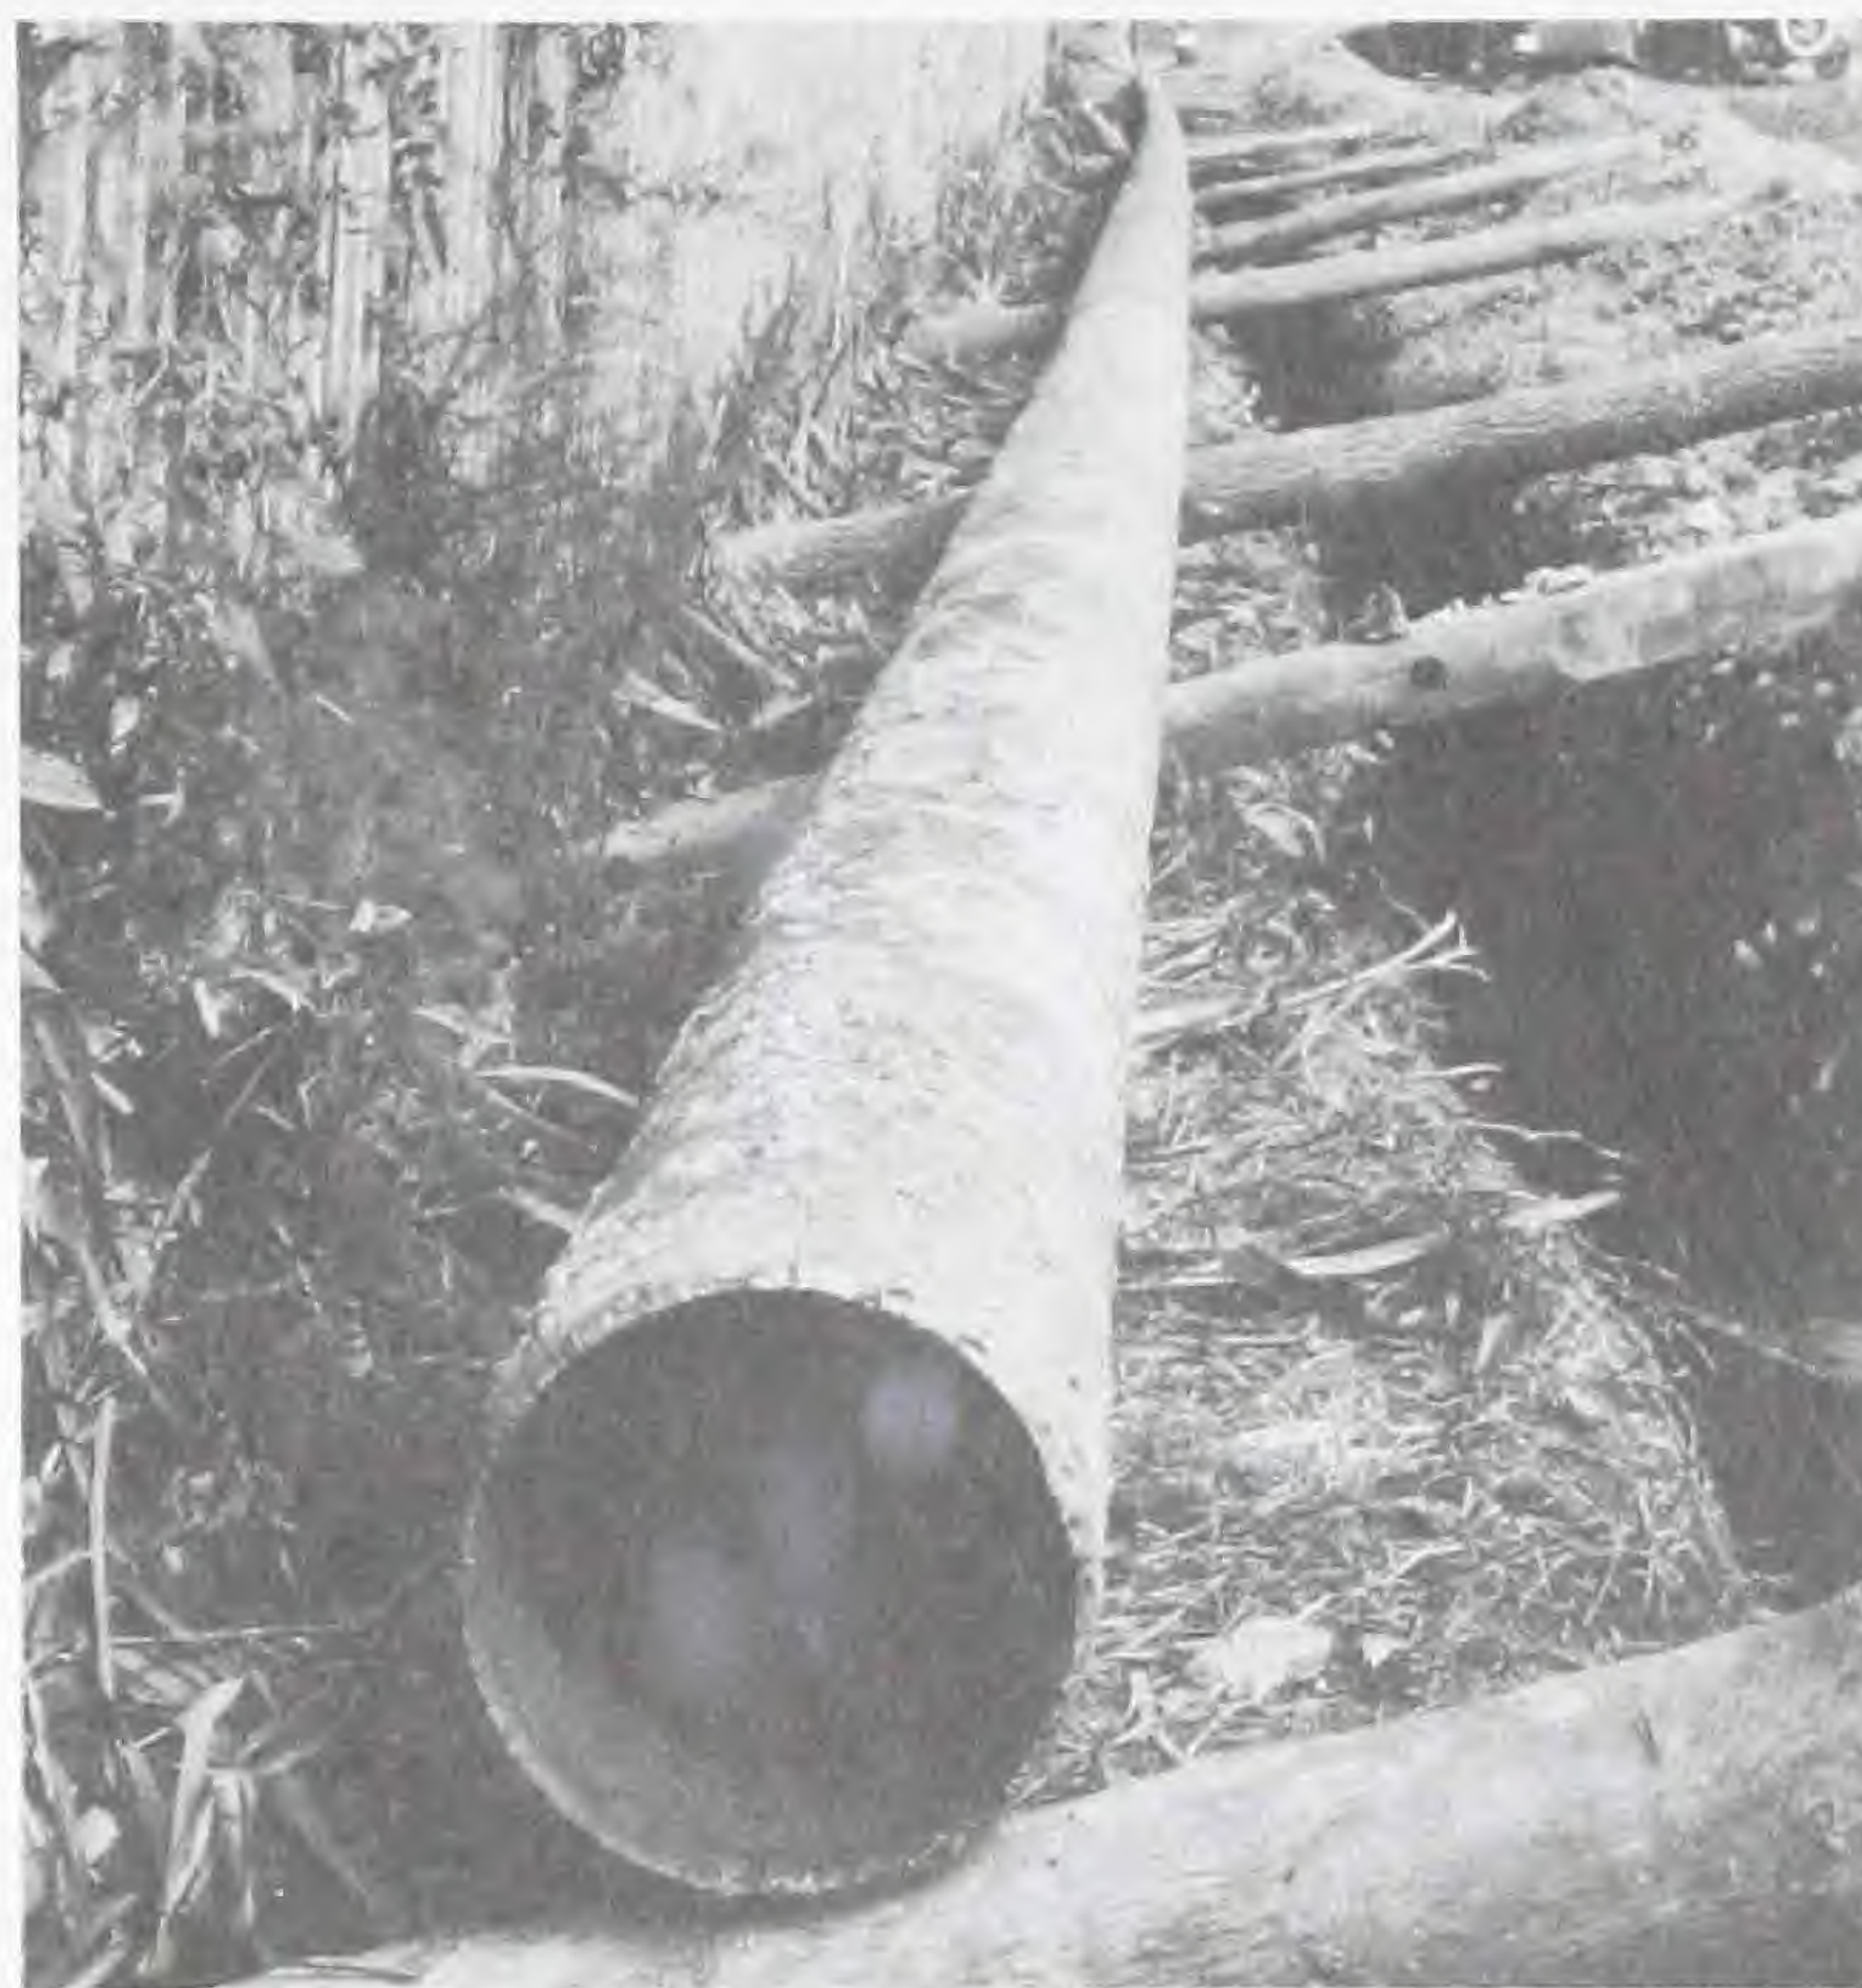
The 8" wrought iron gas line which runs from Bradenburg to Louisville, Ky., has had an interesting history. It originally extended from West Point, Kentucky, to Louisville, Kentucky, and was fifty years old when re-located. Fig. 28 shows the old pipe as it was taken from the trench and Fig. 29 shows it being welded together again prior to re-laying. The excellent condition of the pipe is apparent, and no leaks could be found.
